OTTER HOME INSPECTIONS

RESIDENTIAL INSPECTION

26932 117th St NW
Zimmerman, MN 55398

Micah Digatono
DECEMBER 29, 2022

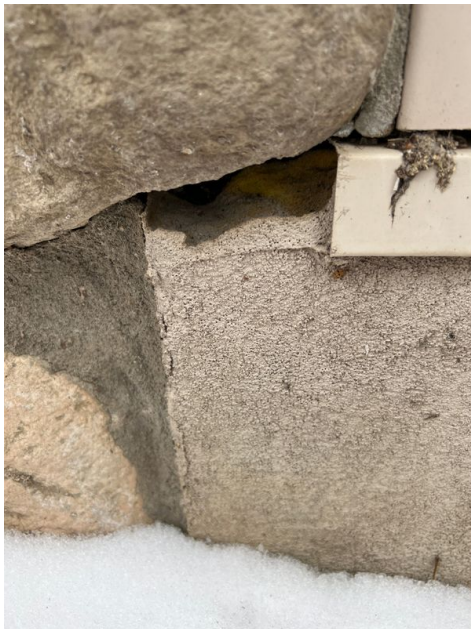
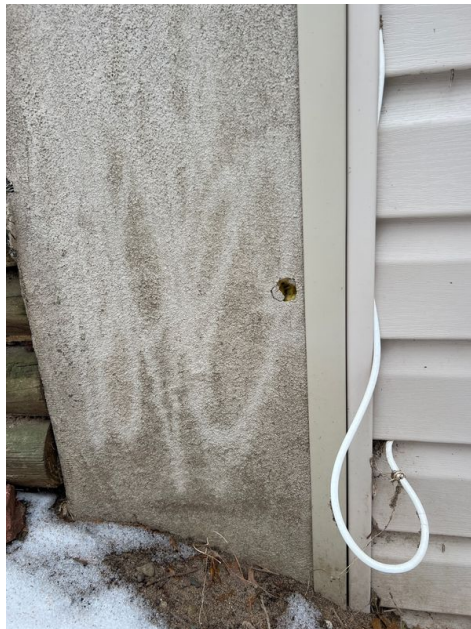
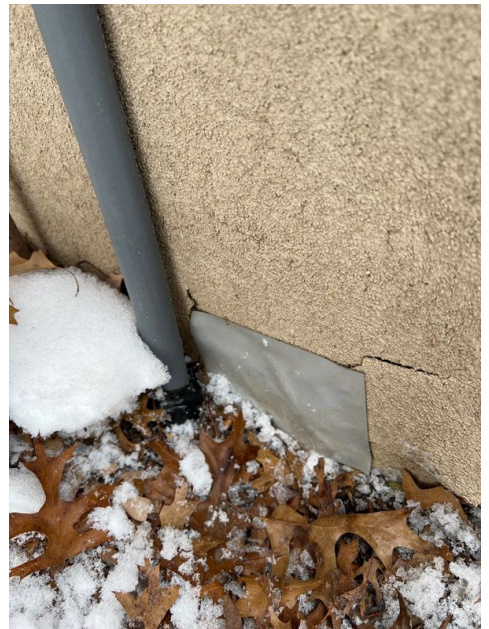
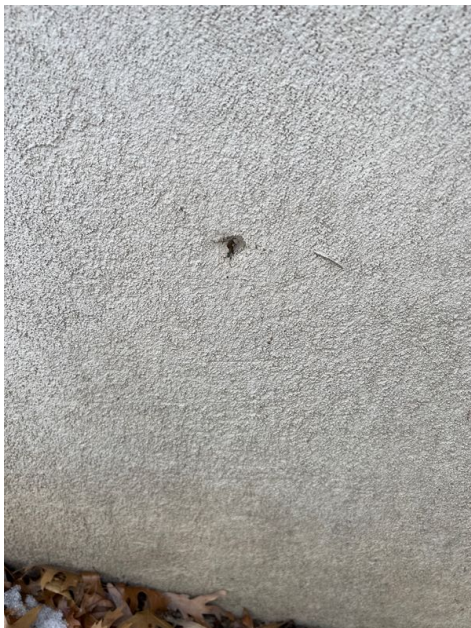
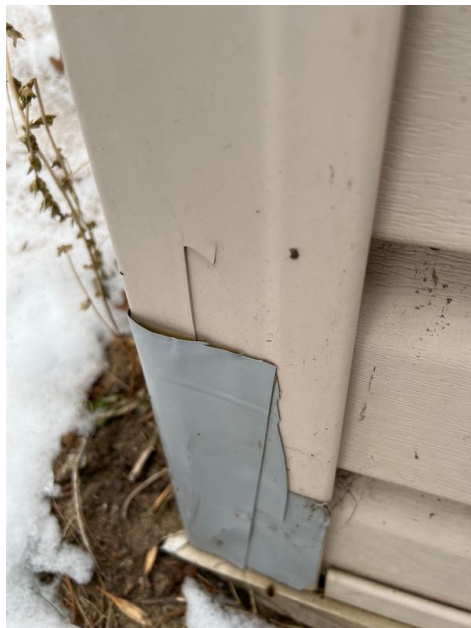
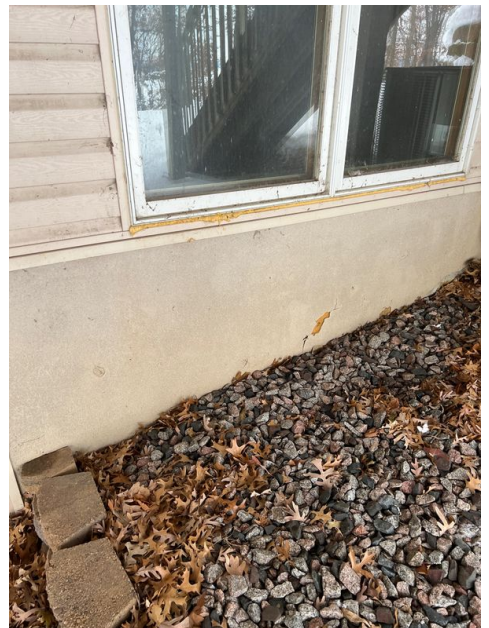
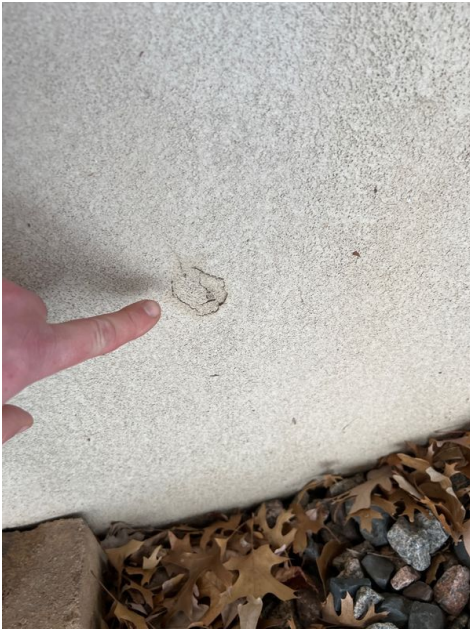
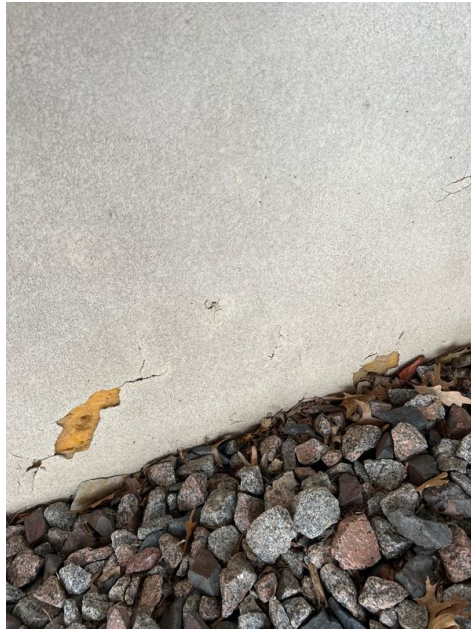
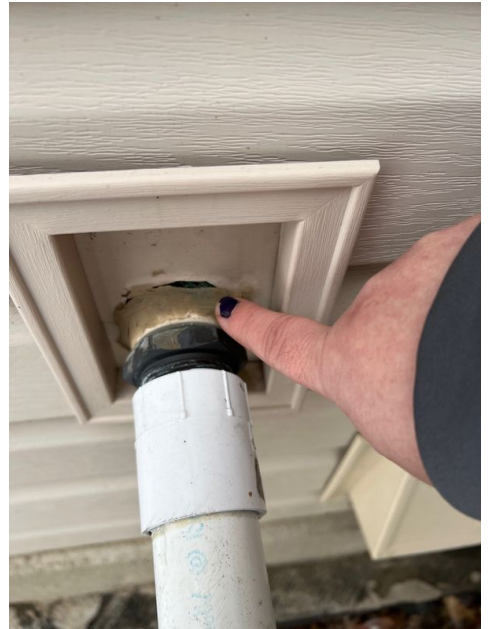
Exterior wall penetrations had gaps that should be sealed with an appropriate sealant to prevent moisture and insect entry.

Contact a qualified professional.

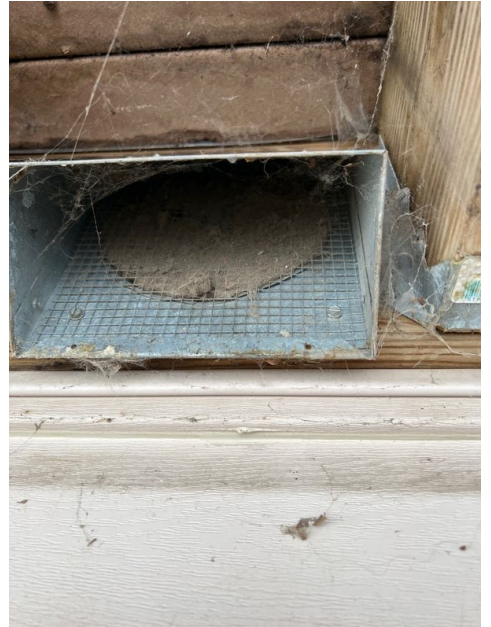
2.3.2 Wall Exteriors

CLOGGED EXTERIOR VENT

Recommended DIY Project

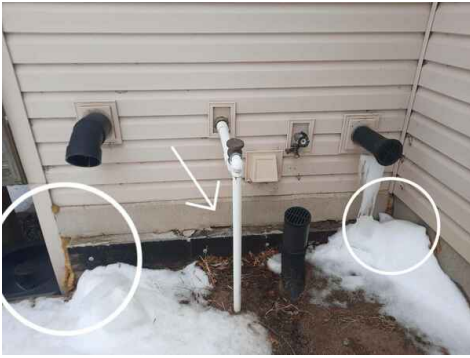
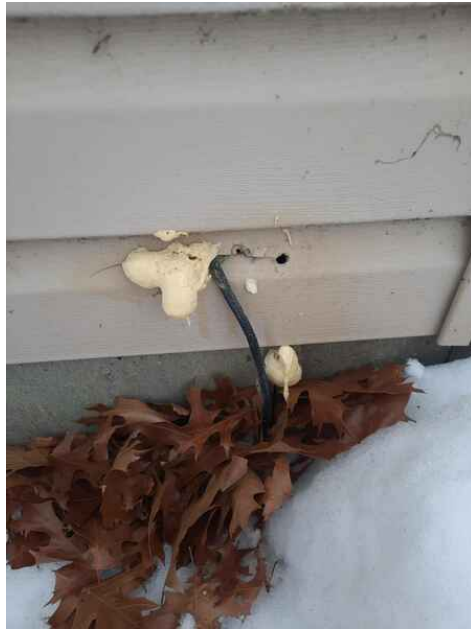
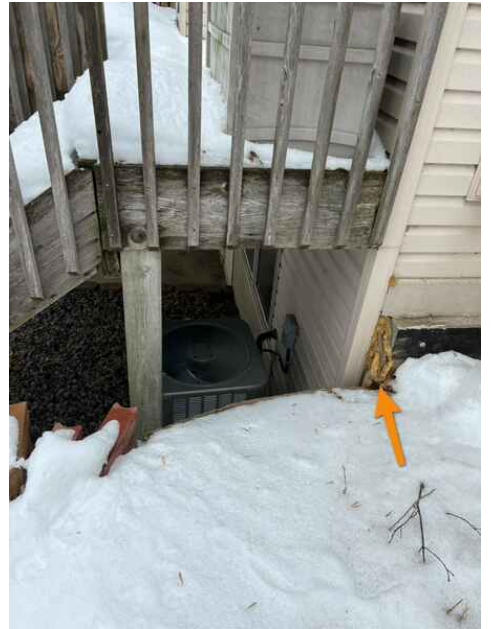
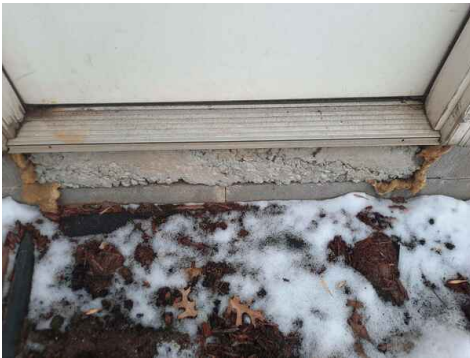
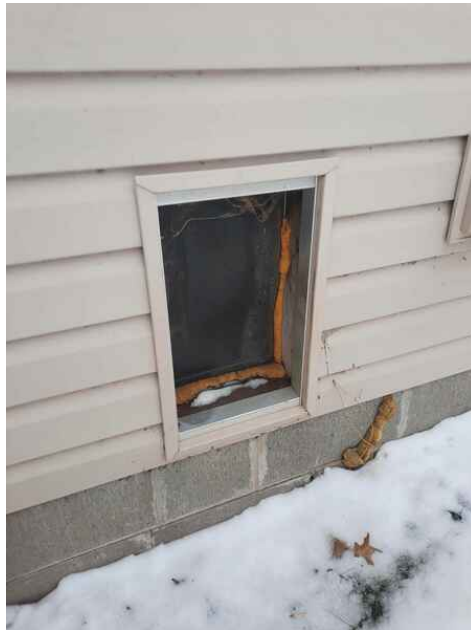
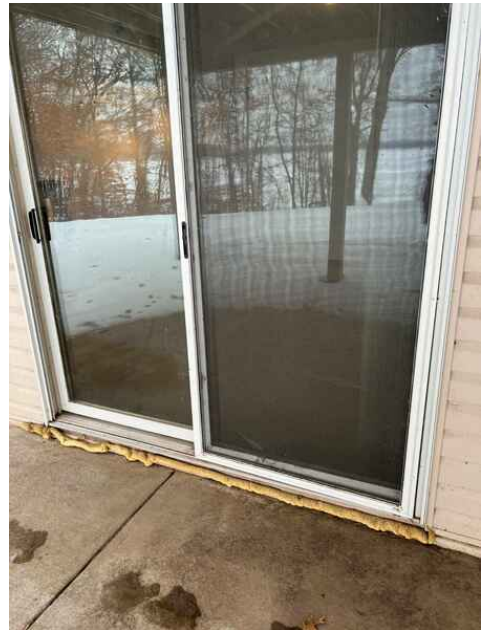
2.3.3 Wall Exteriors

PENETRATION REPAIR ATTEMPTED.

There are penetrations that appear to have been attempted to be repaired by the home owner. These along with all other penetrations need to be evaluated and repaired by a qualified professional.

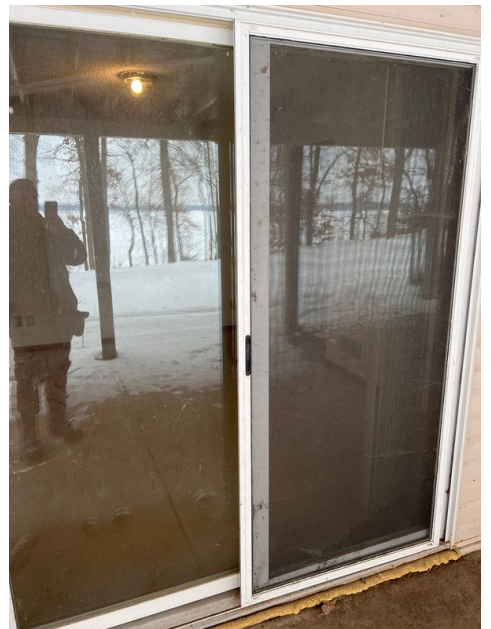
2.4.1 Door/Window Exteriors

DOOR: DAMAGE, LIGHT

An exterior door exhibited light damage. Door doesn't open or shut properly.

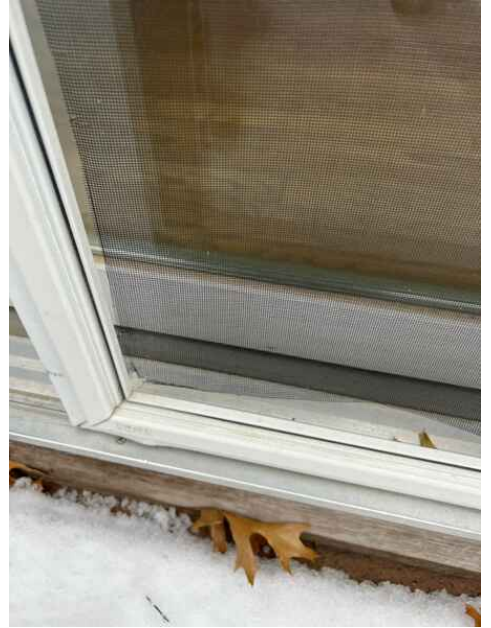
2.4.2 Door/Window Exteriors

DOOR: DAMAGE, MODERATE

SCREEN DOOR AT DECK

An exterior door exhibited moderate damage.

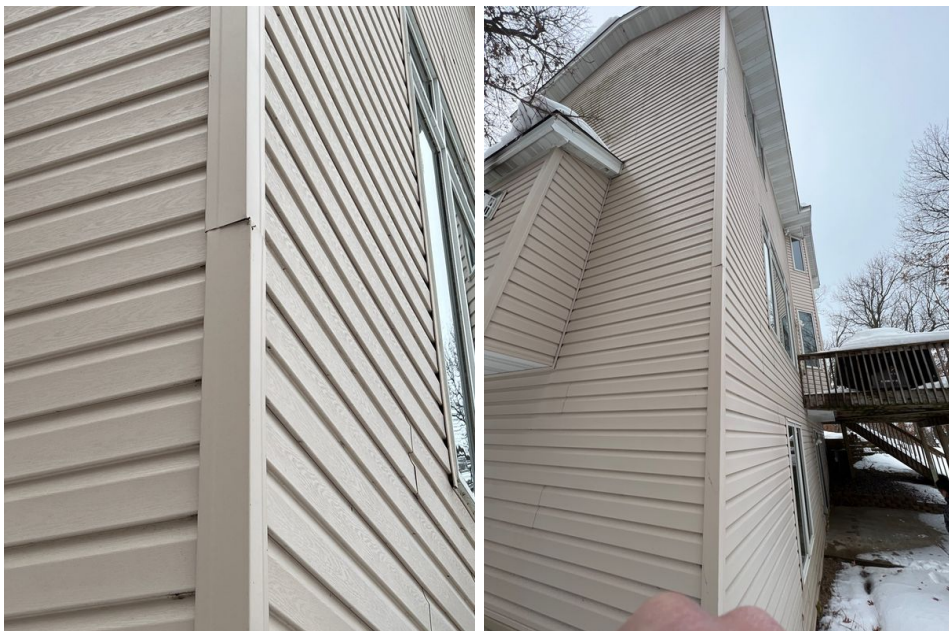
CORNER TRIM: INSTALLATION POOR, SOME

Corner trim was poorly installed in some areas.

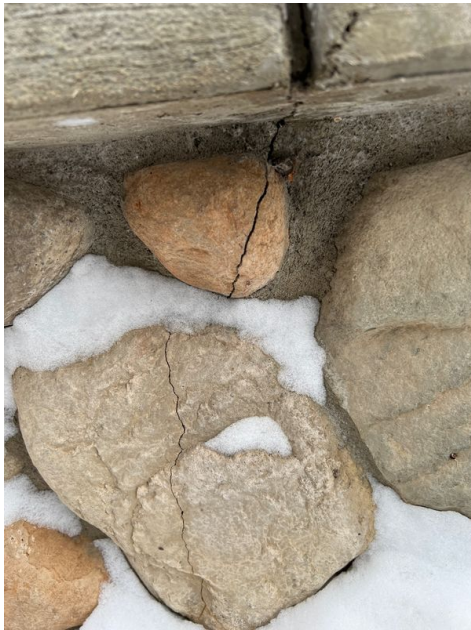
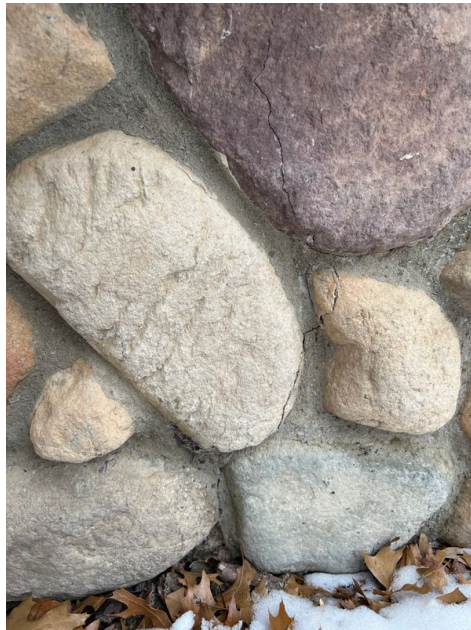
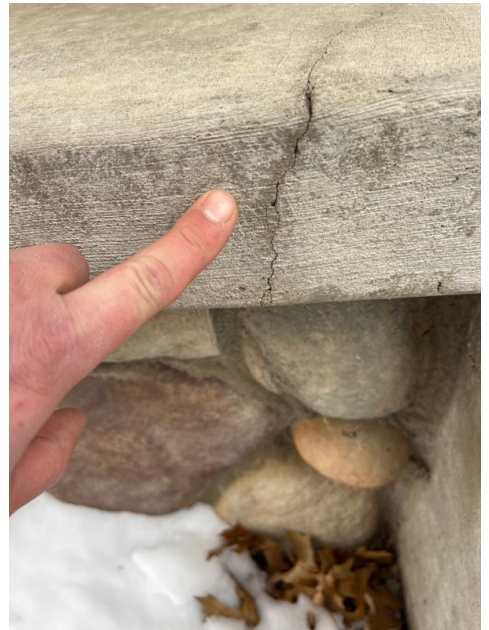
2.6.1 Porch

FOUNDATION CRACKING: MODERATE- SE/QC

Moderate porch foundation cracking was visible. This condition appeared to be consistent with cracking caused by soil movement. If this condition was caused by inadequate compaction at the time of original construction, soil will have stabilized by now. If it was caused by expansive soil, or excessive amounts of moisture in the soil supporting the foundation, movement and cracking may continue. Determining the soil condition would require the services of a soils (geotechnical) engineer. The Inspector recommends crack repair by a qualified contractor to help prevent future damage from freezing moisture.

Contact a foundation contractor.

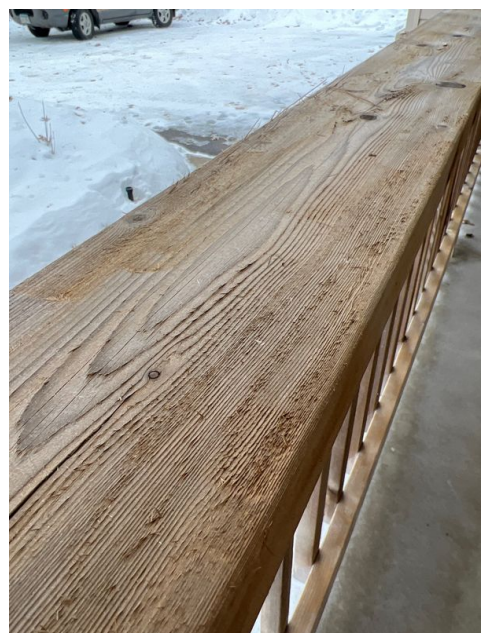
2.6.2 Porch

Handrail components of the porch guardrail assemblies were rough and may cause splinters.

Contact a qualified professional.

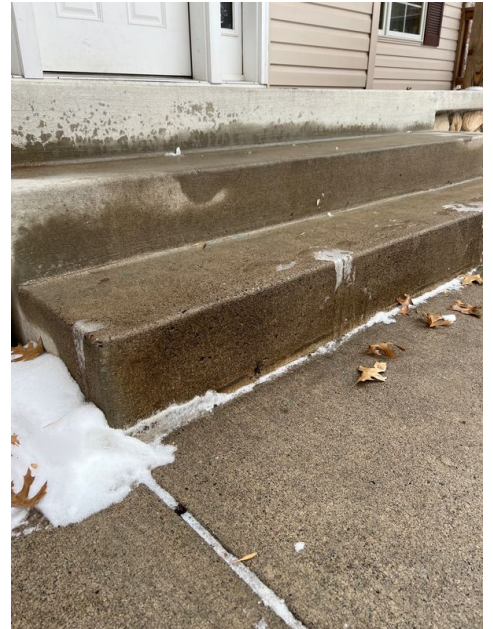
2.6.3 Porch

STAIRS: RISERS, EXCESSIVE VARIATION- QC

Risers at the steps to this porch varied more than the 3/8-inch considered to be the safe maximum by modern safety standards. This condition is a potential fall hazard. All corrections should be made by a qualified contractor.

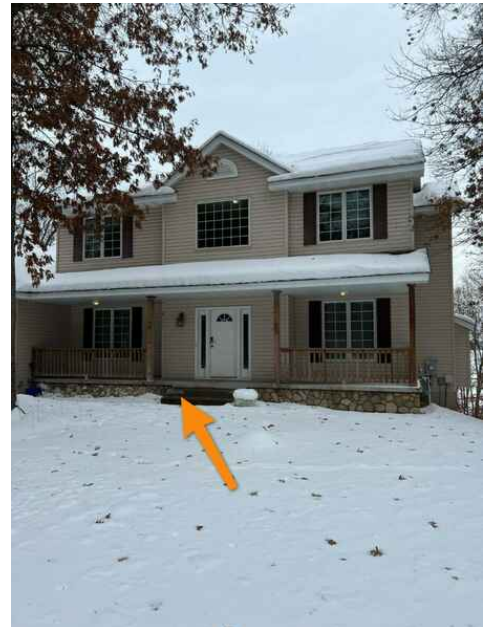
2.6.4 Porch

HAND RAILS MISSING AT STEPS

It was observed that one or more steps were missing a hand rail. For the safety of children and the elderly there should be hand rails at all outdoor steps.

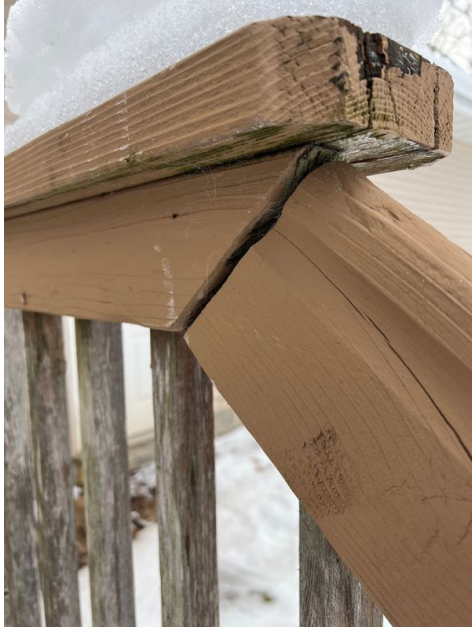
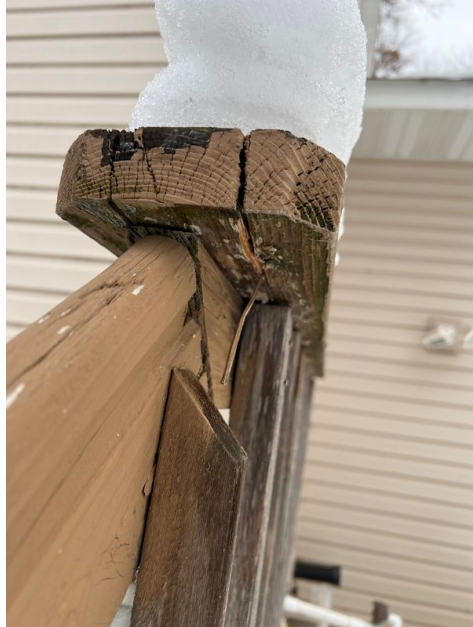
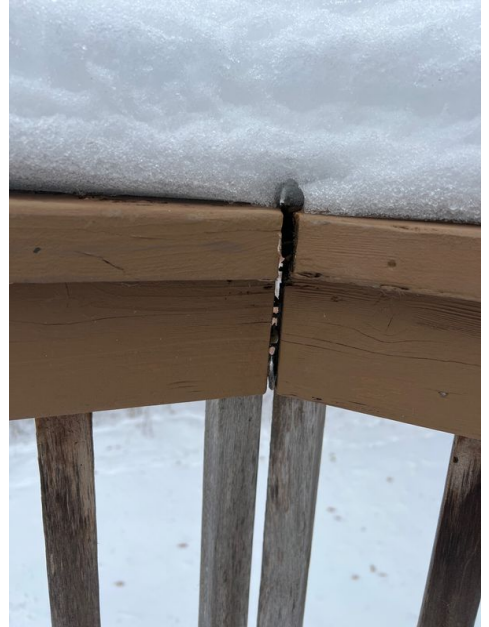
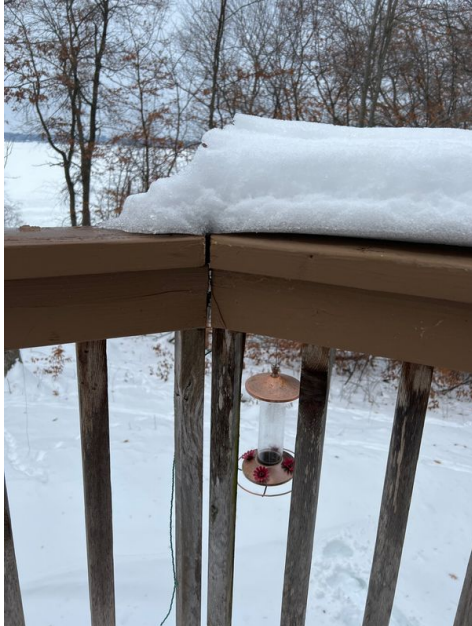
GUARDRAILS: DETERIORATION, MODERATE

At the time of the inspection, the deck guardrail assemblies exhibited moderate deterioration. Providing routine maintenance will extend the long-term service life of the guardrails.

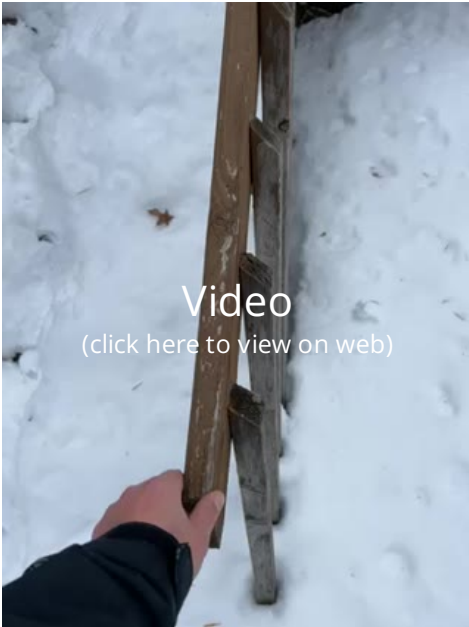
2.7.4 Deck

GUARDRAILS: LOOSE- QC

Deck guardrail assemblies were loose and should be made secure by a qualified contractor.

Contact a qualified carpenter.

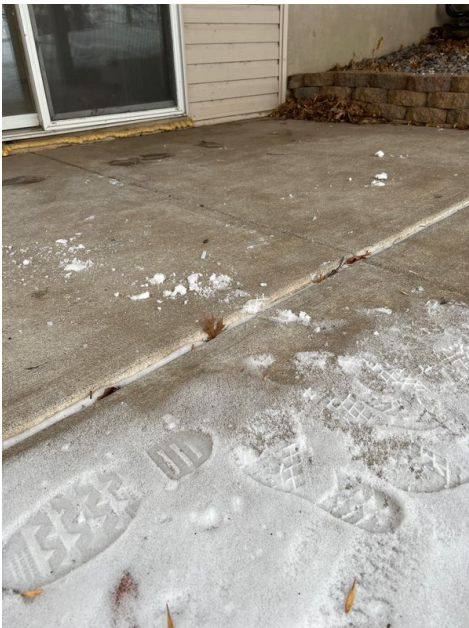
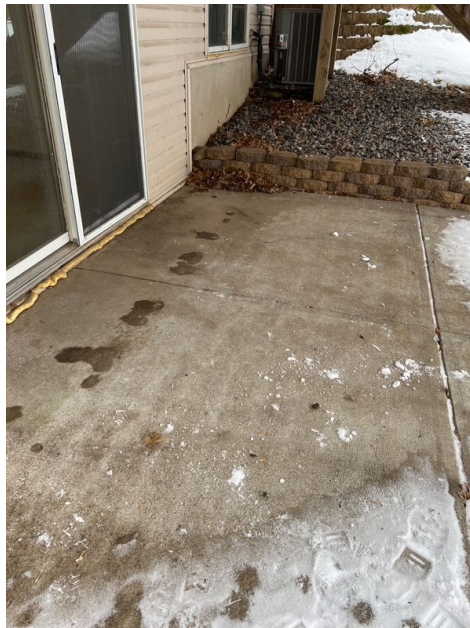
2.8.1 Patio

NOT LEVEL OR FLAT- SOIL SETTLING/HEAVING

The patio was not level or flat. This condition appeared to be the result of settling or heaving of soil, which can have a number of causes. Determining the cause lies beyond the scope of the General Home Inspection.

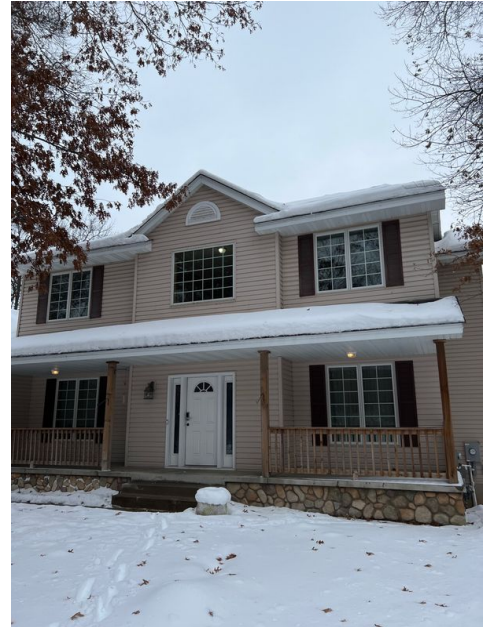
The home had no roof drainage system installed to route roof drainage away from the foundation. Excessively high moisture levels in soil near the foundation can cause damage related to soil/foundation movement.

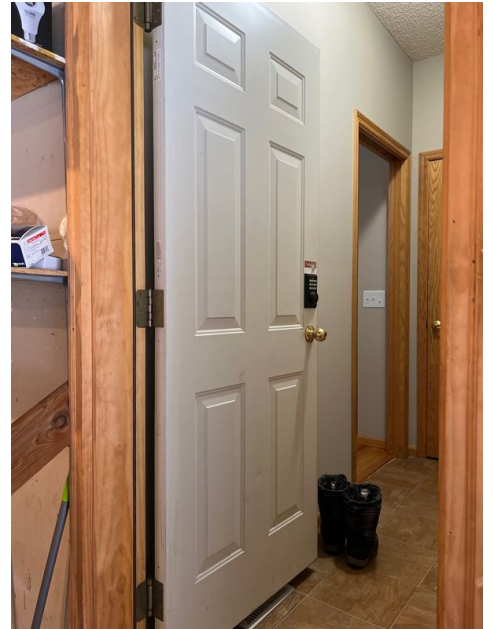
The door in the wall between the garage and the home living space did not have operable self-closing hinges. Self-closing hinges are a safety feature designed to help prevent the spread of fire and toxic fumes from the garage to the living space.

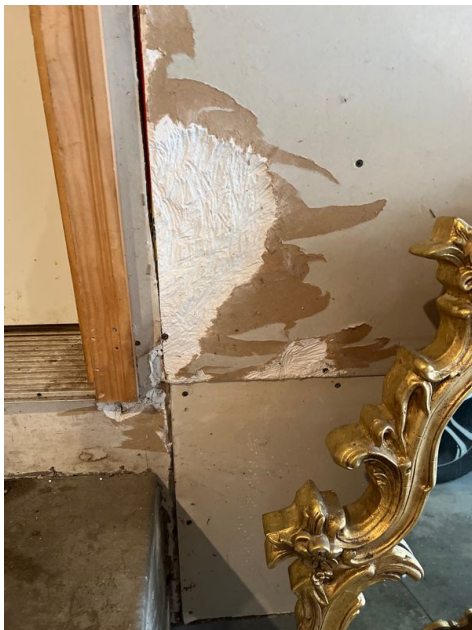
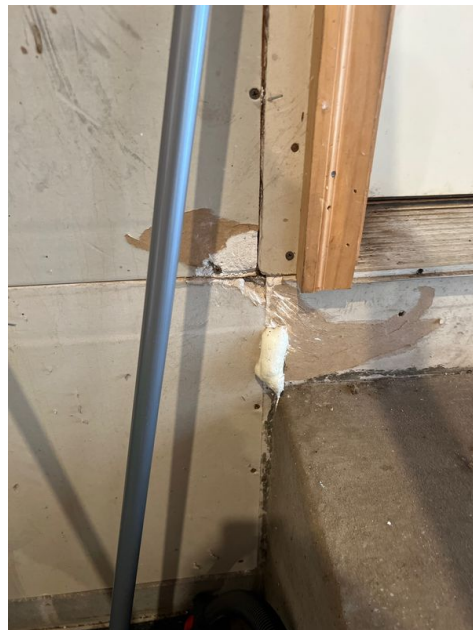
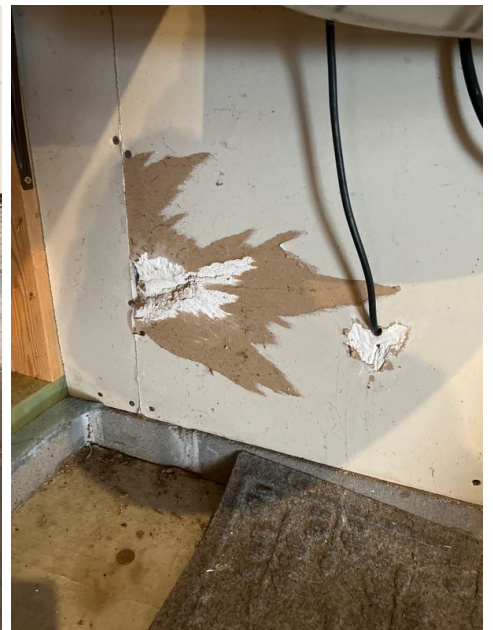
5.3.2 Floors, Walls, & Ceiling

WALLS: DRYWALL DAMAGE, MINOR

The garage walls exhibited minor drywall damage.

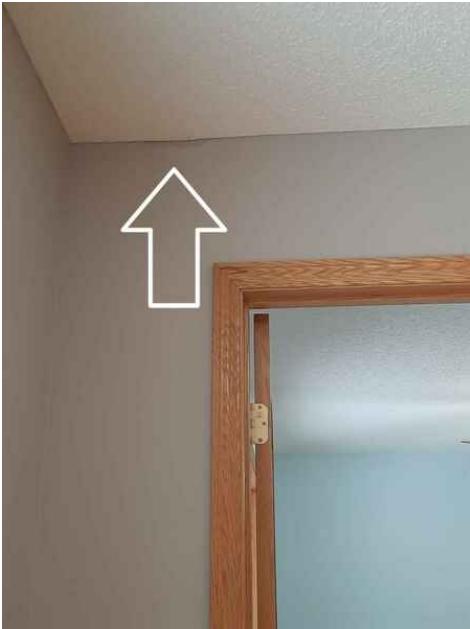
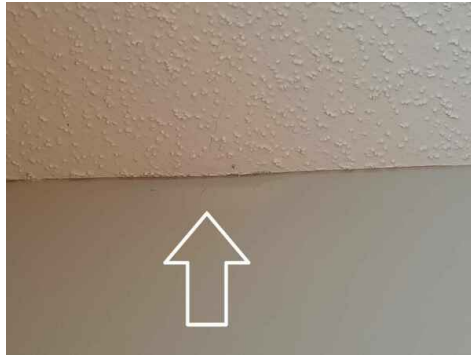
DAMAGE & DETERIORATION, MINOR (SPEC.)

Interior walls in the __ exhibited minor damage or deterioration.

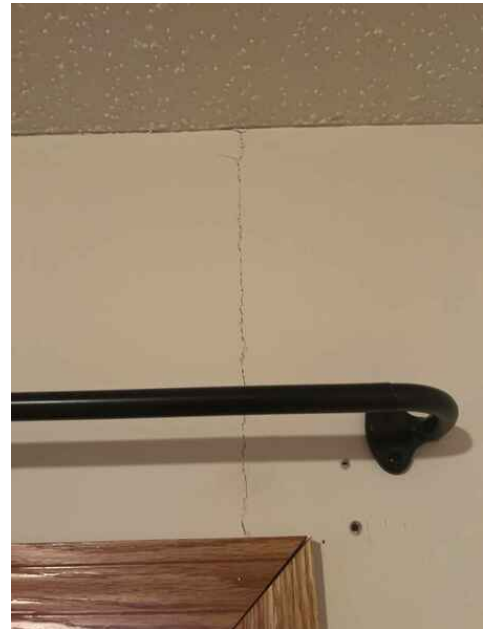
6.3.2 Walls

CRACKING, VERTICAL CRACKS ON INTERIOR WALL

Vertical cracks were observed on interior walls. This is most likely caused by seasonal changes and or lack of gutters. Inspector recommends installing gutters and monitoring the crack if it gets larger further evaluation by a Qualified professional is recommended.

Contact a qualified professional.

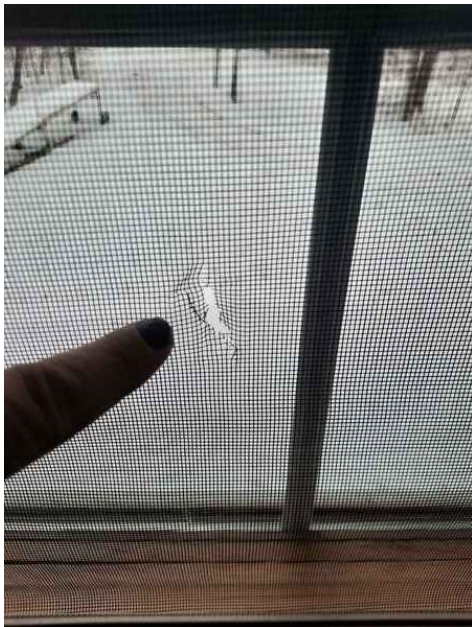
6.10.1 Windows

SCREEN, DAMAGED OR MISSING

It was observed that a screen was missing or damaged at a door or window. Screens are used to keep out insects while allowing fresh outdoor air to enter the house. It is recommended the screen be repaired or replaced.

Contact a handyman or DIY project

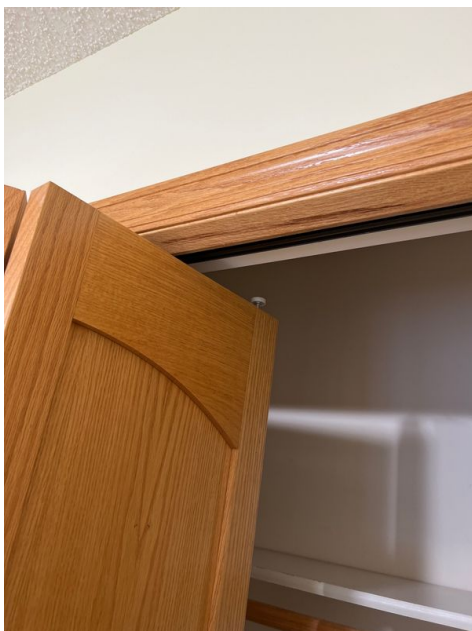
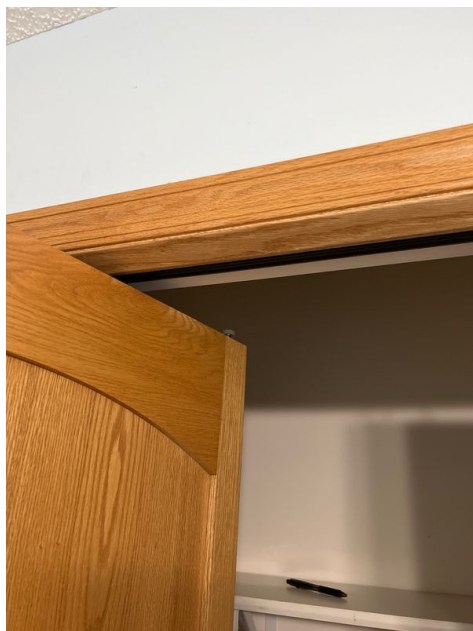
6.12.1 Bedroom

DOOR, INT.: CLOSET DOORS INSTALLATION, POOR OPERATION- QC

Closet doors in this bedroom were poorly installed and did not operate well. The Inspector recommends service by a qualified contractor.

Contact a qualified professional.

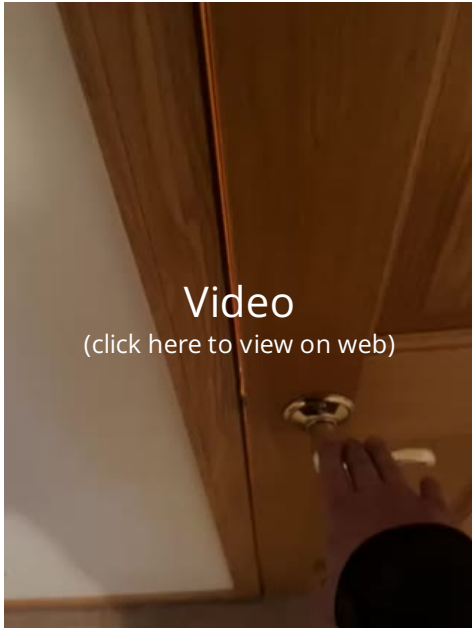
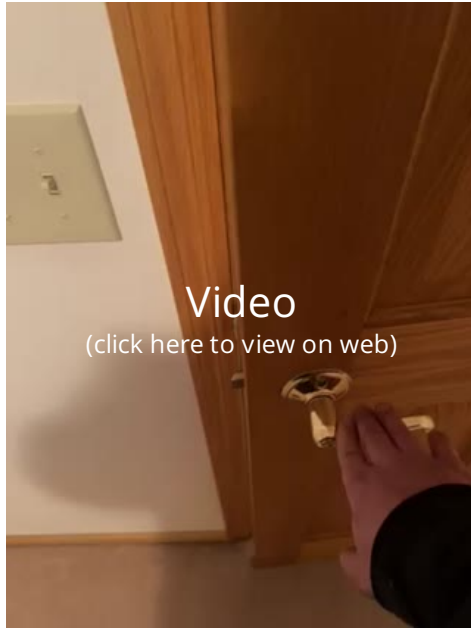
6.12.2 Bedroom

DOOR, INT.: IMPROPER OPERATION- QC

The doorknob of an interior door in this bedroom did not operate properly and needed adjustment or replacement. All work should be performed by a qualified contractor.

Contact a qualified professional.

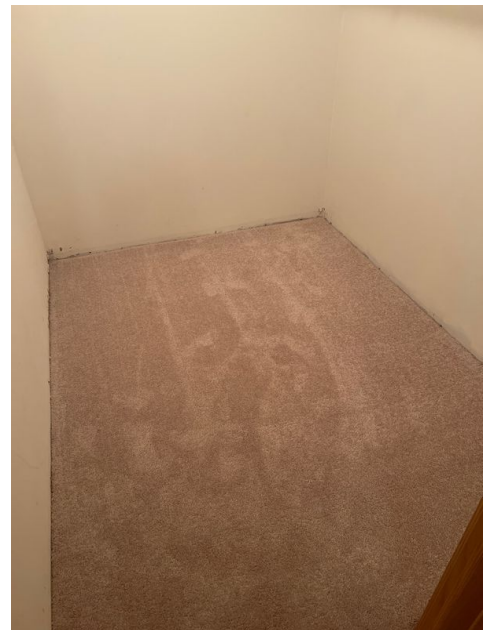
6.12.3 Bedroom

INTERIOR TRIM: MISSING, ___- QC

Interior trim was missing in this bedroom. The Inspector recommends repair or replacement by a qualified contractor.

Contact a qualified professional.

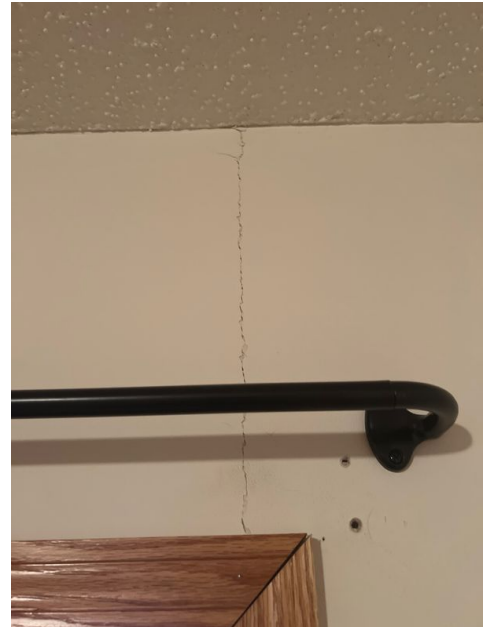
Moderate Concern/Repair**WALLS: CRACKING, DIAGONAL,
DOORS/WINDOWS- QC/SE**

Diagonal cracking visible at the corners of doors and windows in walls in this bedroom are typical of cracks caused by soil movement. Determining the likelihood of continuing damage lies beyond the scope of the General Home Inspection and would require the services of a qualified foundation repair contractor or a structural engineer.

Contact a qualified professional.

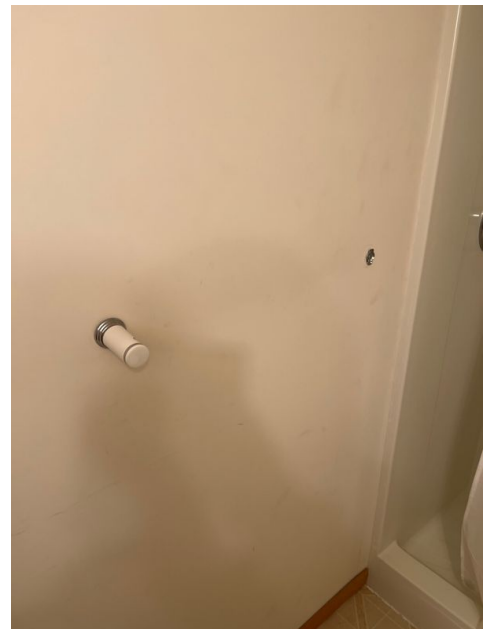
6.13.1 Bathroom

Minor Concern/Maintenance needed**TOWEL RACK BROKEN
OR MISSING**

It was observed that the towel rack was broken or missing

Recommended DIY Project

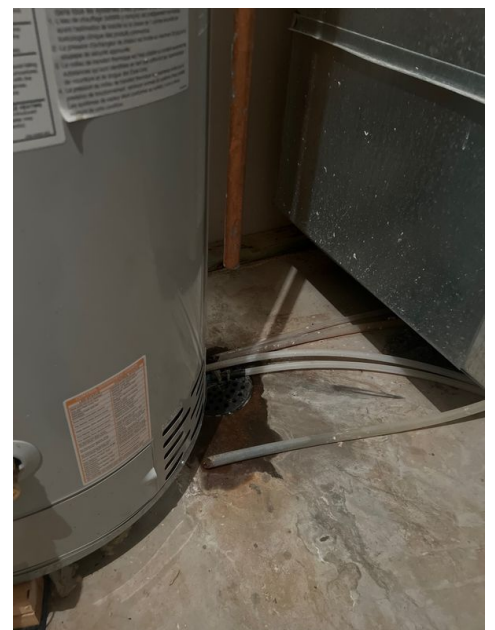
The discharge pipe of the water heater temperature/pressure relief (TPR) valve was terminated more than 6 inches above the floor. This condition is a potential scald hazard and should be corrected by a qualified plumbing contractor.

Contact a qualified plumbing contractor.

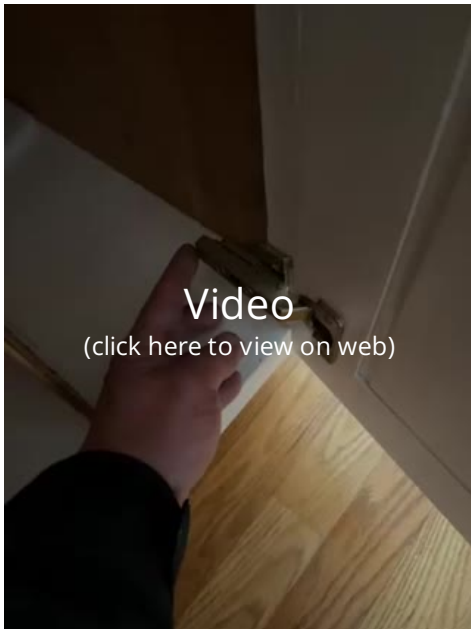
DOOR HINGES LOOSE

The kitchen cabinets had a number of loose door hinges.

Contact a qualified handyman.
