OTTER HOME INSPECTIONS

RESIDENTIAL INSPECTION

26932 117th St NW
Zimmerman, MN 55398

Micah Digatono
DECEMBER 29, 2022

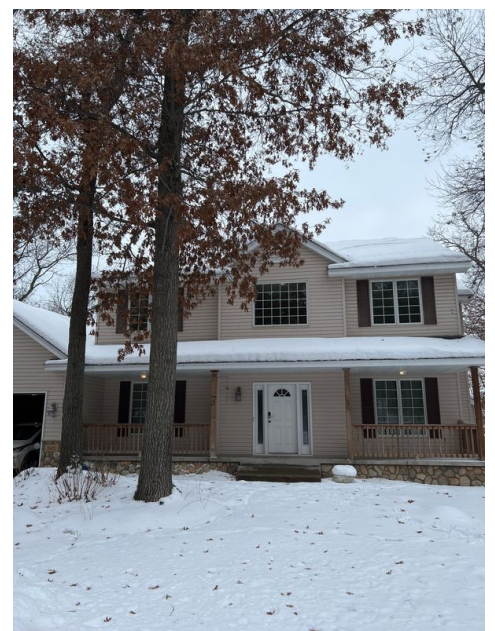
SNOW LIMITED INSPECTION

The Inspector was unable to directly view the roof-covering material. It was covered with snow.

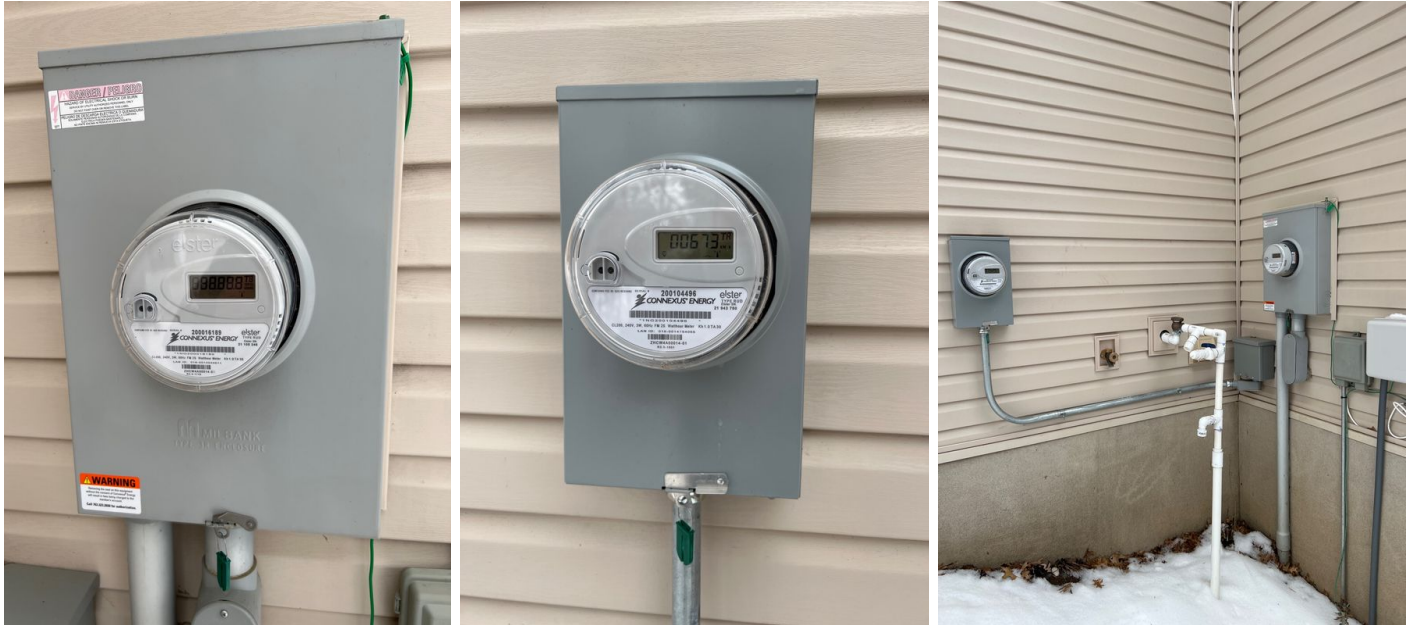
**Service Grounding & Bonding: Grounding electrode system: driven rod**

The service panel had a grounding electrode conductor (GEC) visible that was bonded to the service panel and that was properly clamped to the top of a driven rod that serves as the grounding electrode. Driven rods are typically an 8-foot copper or steel rod required to be driven into the soil for its full length. The inspector was unable to confirm the length of the driven rod. Evaluation of the effectiveness of the service ground would require the services of a qualified electrical contractor using special instruments.

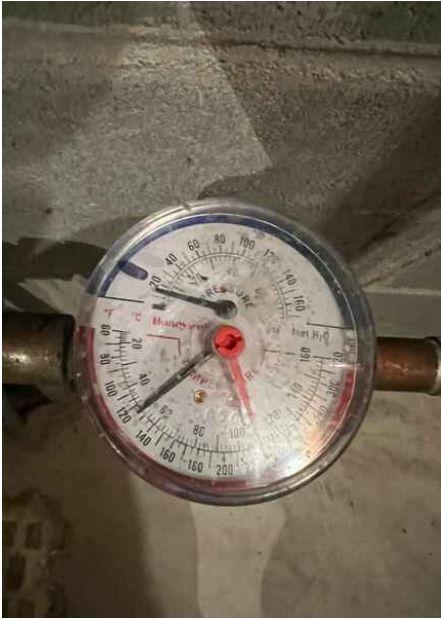
**Boiler: Hydronic Heating: Boiler:
gauge photo**

The boiler pressure/temperature gauge is shown in the photo.

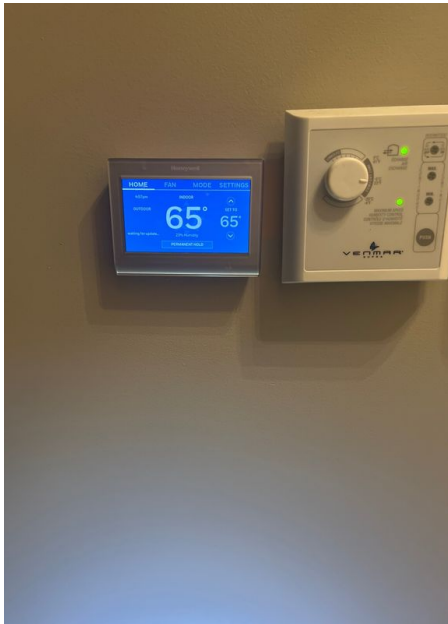
The furnace and the air-conditioning were controlled by a programmable thermostat. Heating and cooling costs can be reduced by programming the thermostat to raise and lower home temperatures at key times.

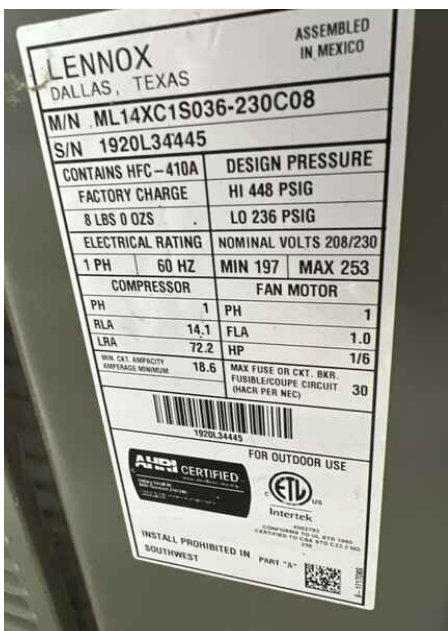
Cooling: Condenser: data plate, photo

Information from the air-conditioner compressor unit data plate is shown in the photo.
